Your Inspection Report

6 Bigham Cres
Toronto, ON

INSPECTION DATE:
Monday, October 17, 2016

RE: Report No. 55664
6 Bigham Cres
Toronto, ON

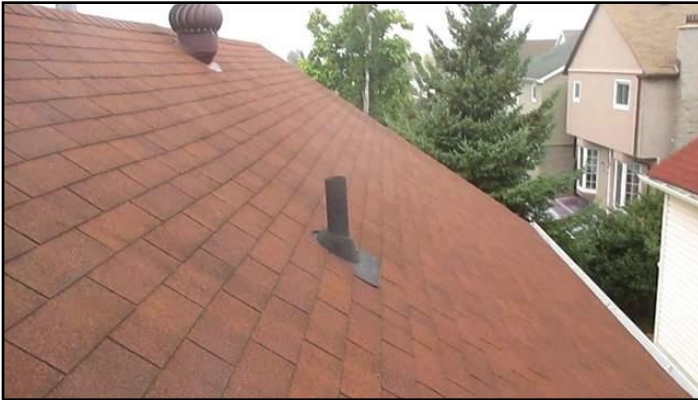
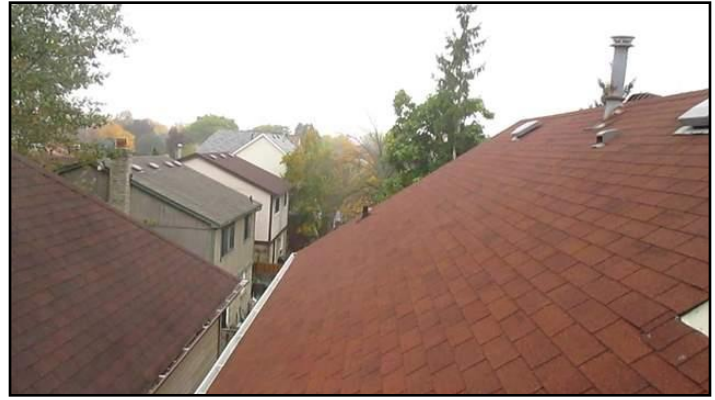
Approximate age: • The roof covering appears to be within the first half of its normal life expectancy.

The roof covering appears to be within the...

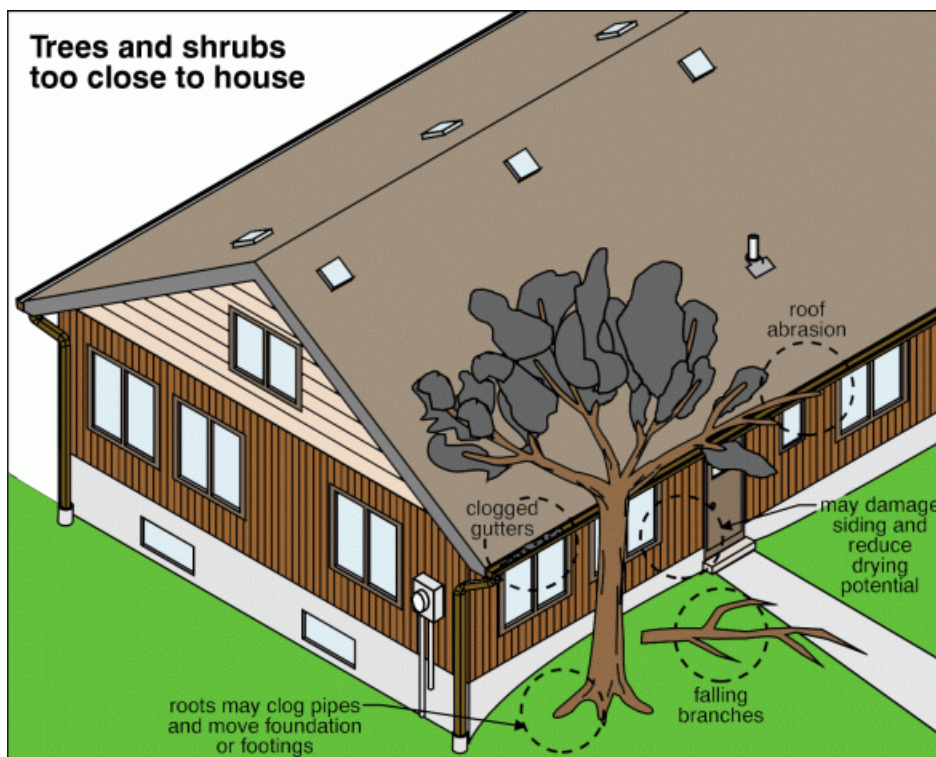
Condition: • [Tree branches rubbing against roof cause wear](#)

Mature trees noted which have been pruned back. Maintain so that branches do not contact roof surface.

Trees also can act as a conduit for vermin access to roof surface and possible entry.

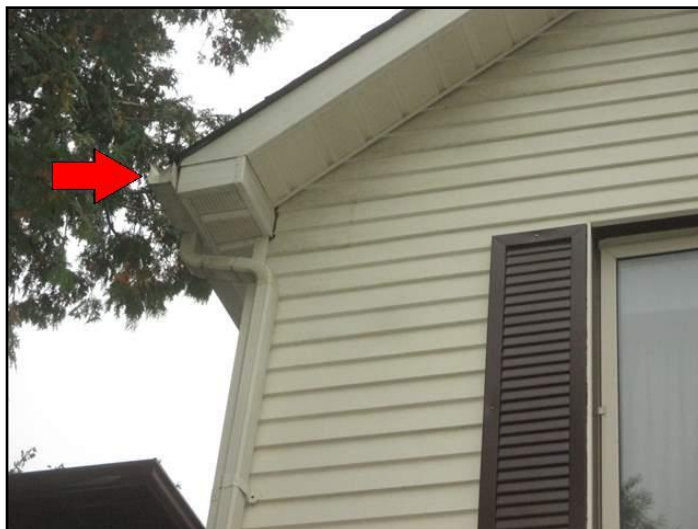
Location: Front Left Side Second Floor

Condition: • [End caps leak/damage/missing](#)

End cap damage

Task: Repair

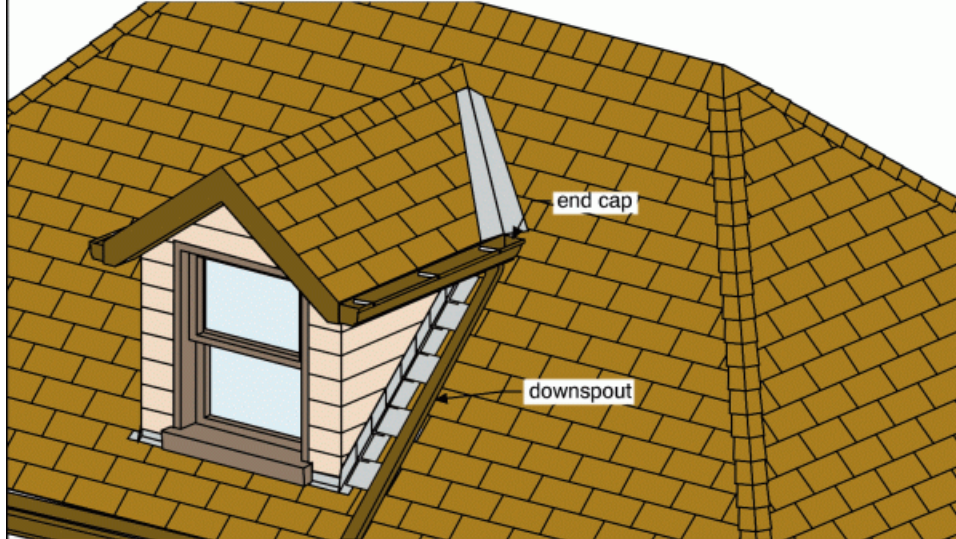
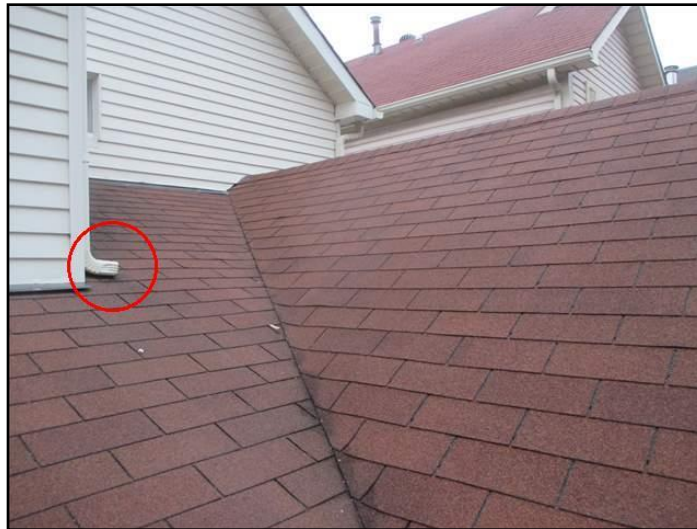
Condition: • [Discharge onto lower roof \(causes premature wear of Roof Covering\); extend to lower Gutter to protect Roof Covering](#)

Downspout running across roof

Discharge onto lower roof (causes premature...

installing a downspout (from the secondary roof to the main gutter below) helps prevent localized roof wear

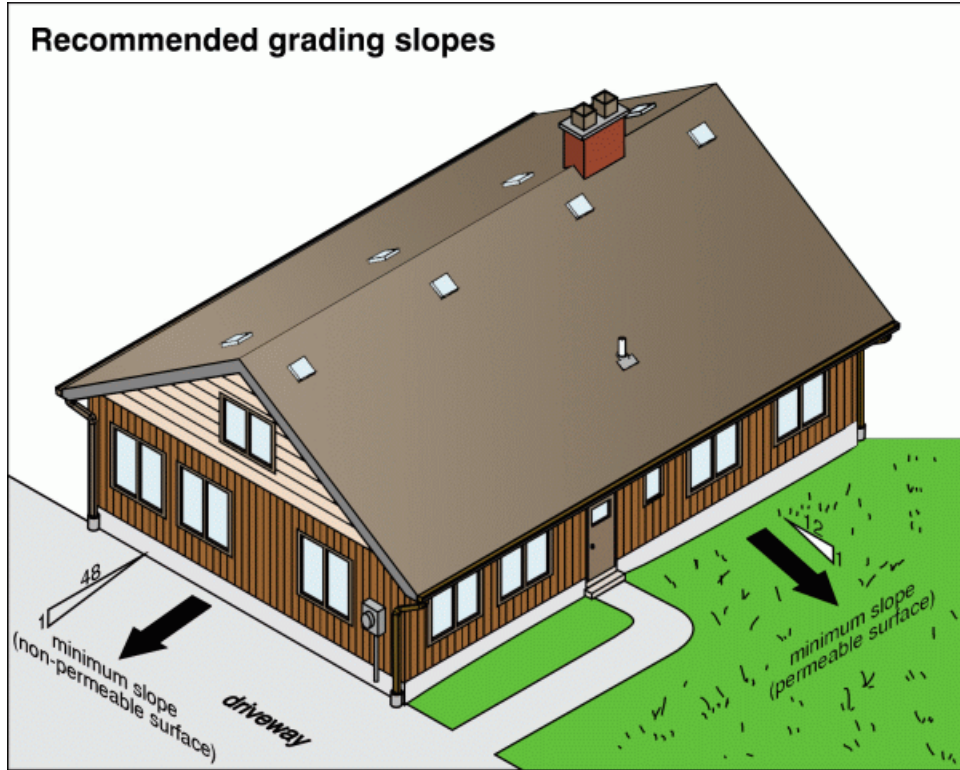
Location: Various

Condition: • [Low areas](#)

A neutral or negative slope will hold moisture against the foundation and increase the possibility of water infiltration. Maintain a positive slope away from the house to help flush water away from the building. It also tends to pool water creating a slip hazard in cold weather. Poor lot grading can contribute to basement leakage. Monitor the drainage in these areas and re-slope/repair as necessary.

Task: Correct

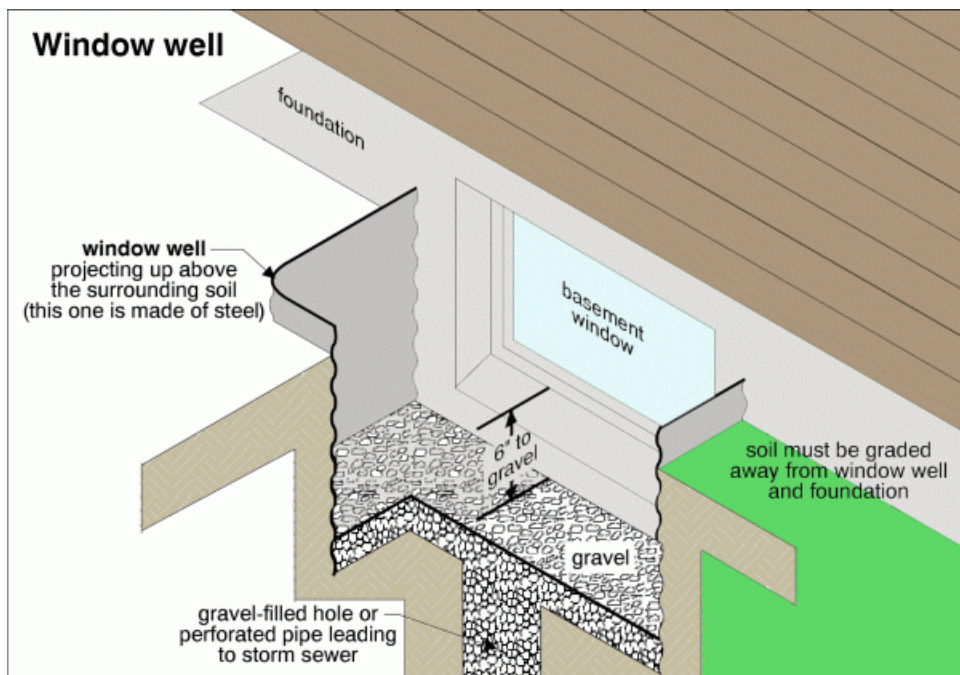
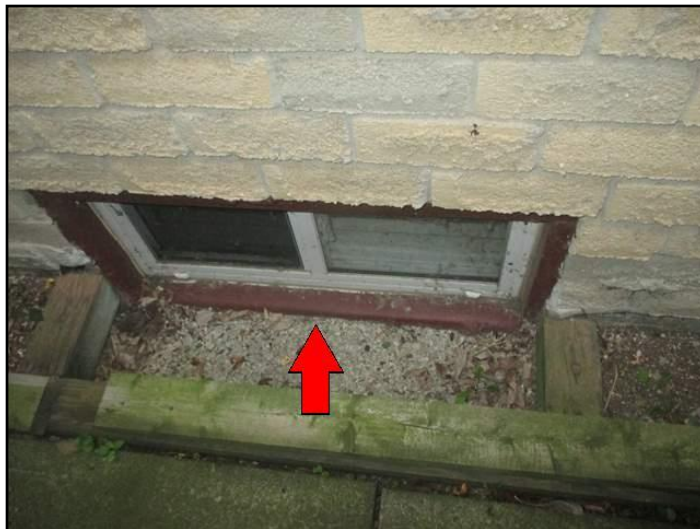
Condition: • Window Well - clearance inadequate below Window Sill

Window Well - clearance inadequate below...

Keep area(s) free of snow and debris to help prevent water infiltration. Unable to determine if drainage tile has been installed at window wells. A plastic cover could help here in the cold season.

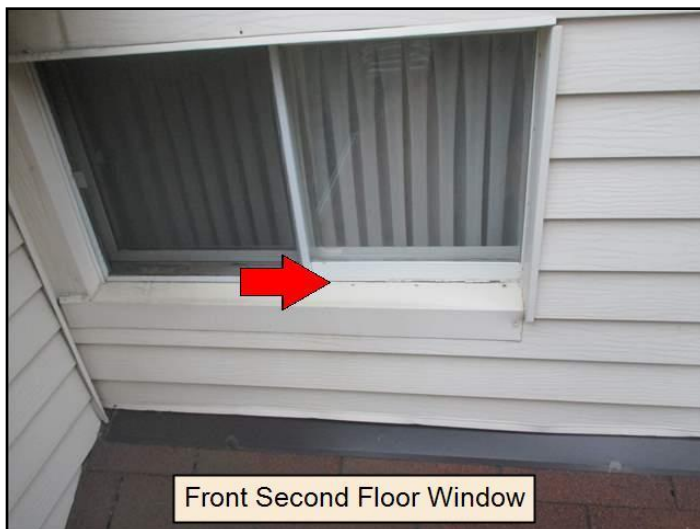
Condition: • [Caulking - deteriorated or missing](#)

Moisture can enter where sealant is missing/ deteriorated and damage area behind. Regularly check at sills, around door areas and any other openings as well.

Example: Caulking - deteriorated or missing

Task: Protect

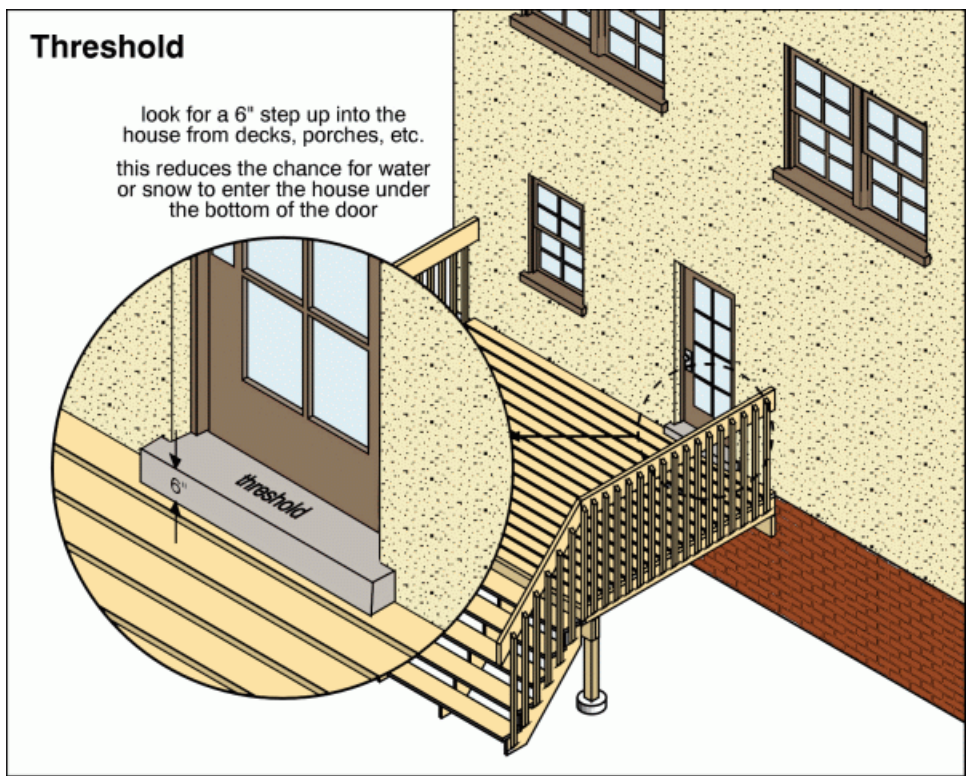
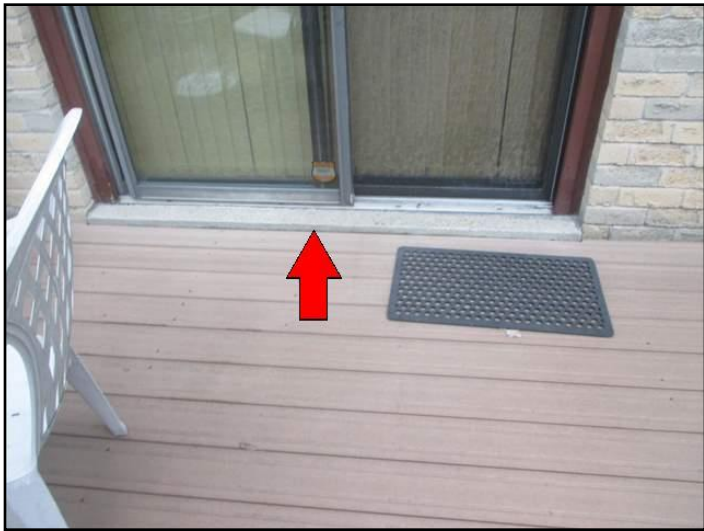
Condition: • [Threshold - clearance inadequate \(above Landing\)](#)

Threshold - clearance inadequate (above...

Keep area clear of snow and debris to help prevent water infiltration.

Task: Repair/replace any damaged wood at base of door frame

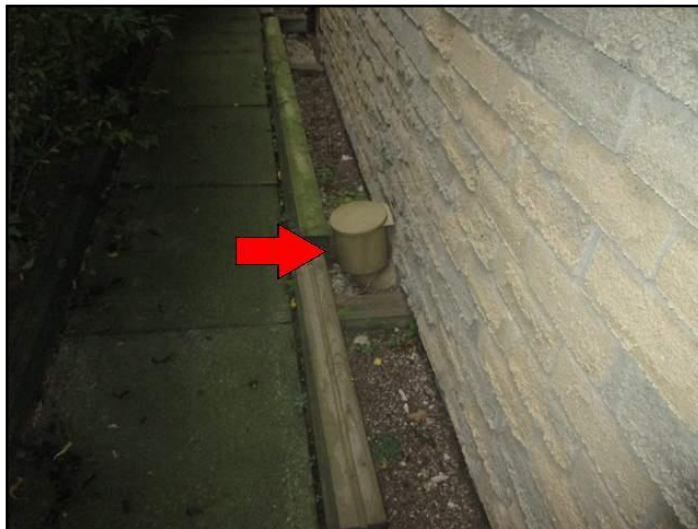
Location: Right Side

Condition: • Vent too close to grade
Keep dryer vent clear of snow and debris. Clean out lint frequently.

Vent too close to grade

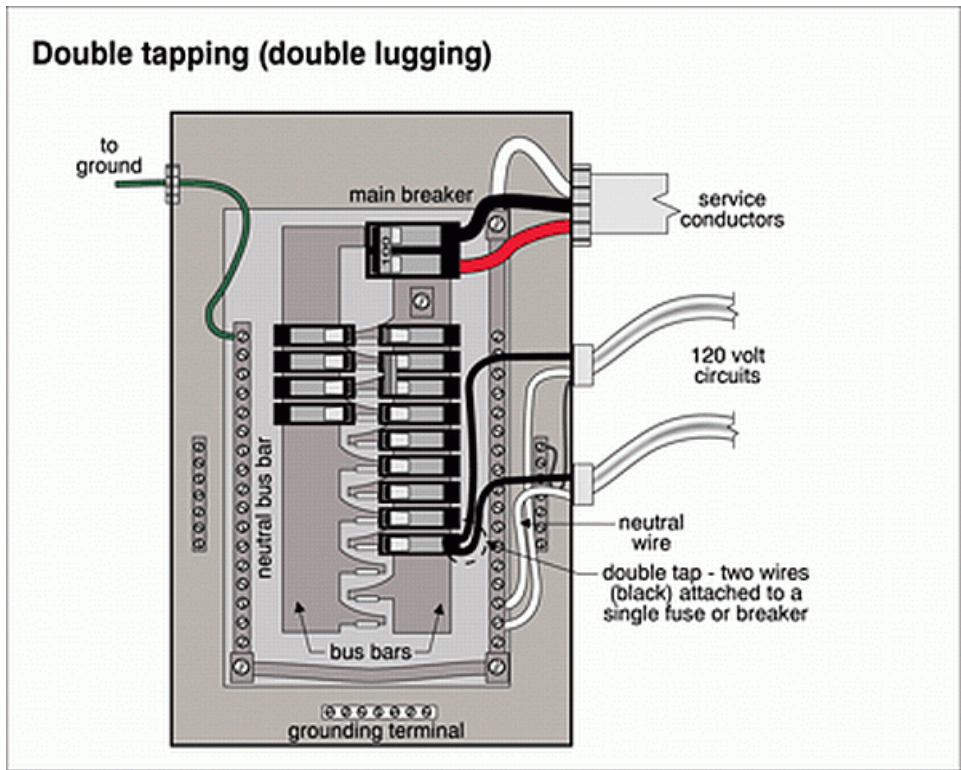
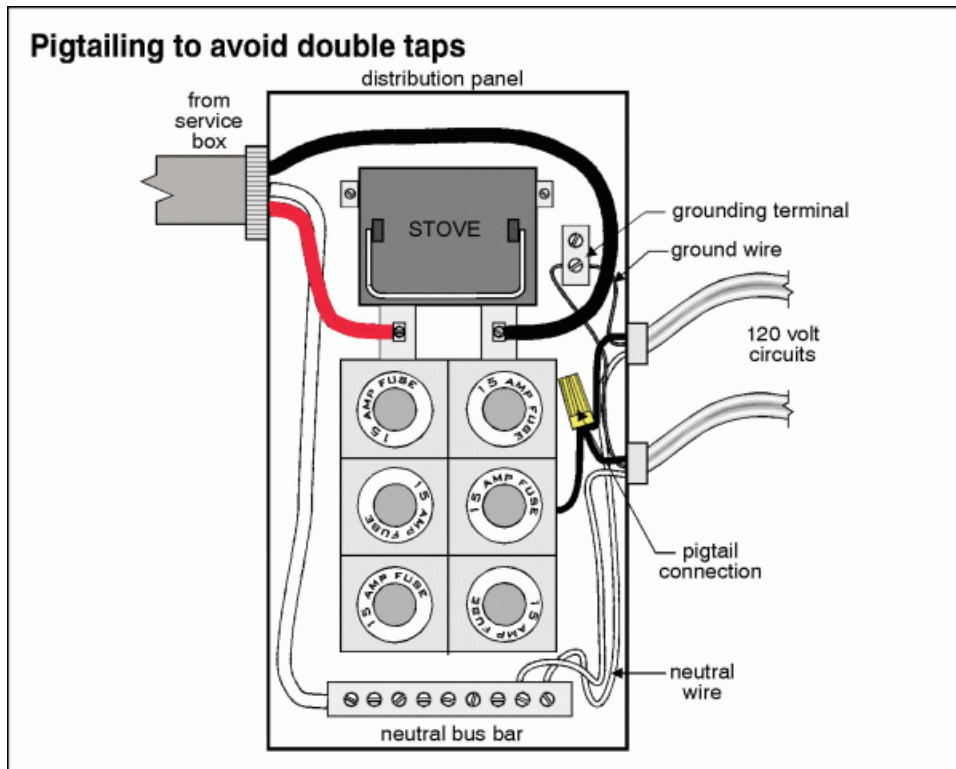
Condition: • [Double tap \(two wires on one breaker or fuse\)](#)

The panel is full. One option is to upgrade the panel. Adding a sub-panel would be a more cost effective alternative - if necessary.

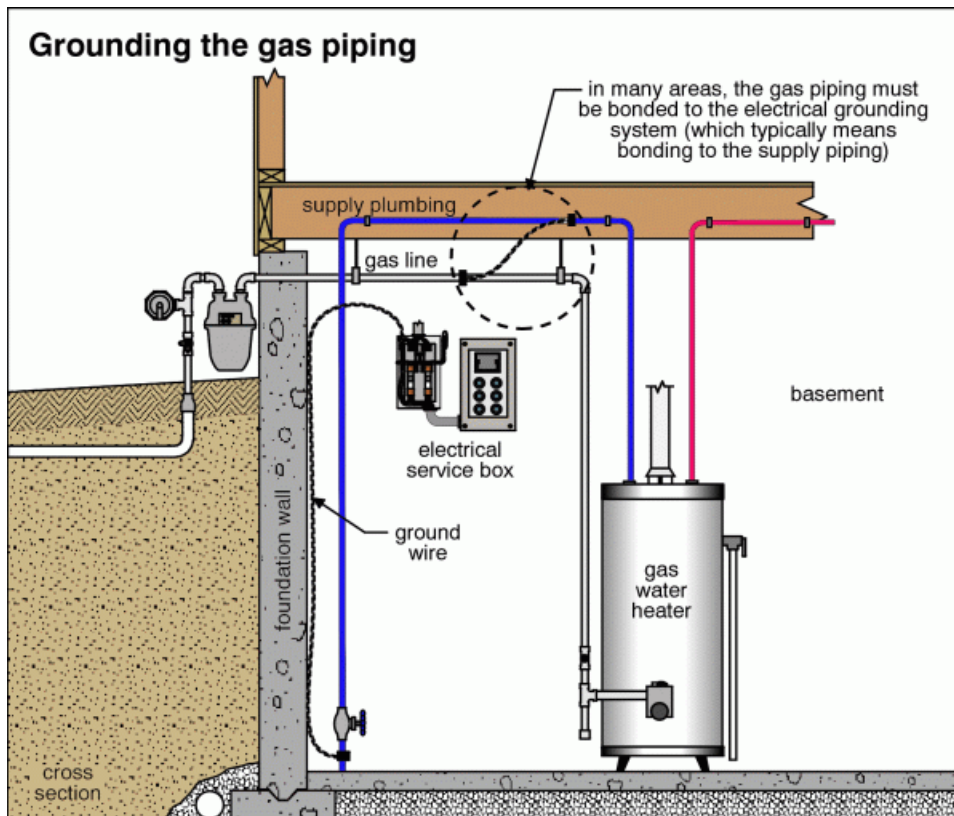
- Condition:** • [Bonding of gas piping not confirmed](#)
- Bonding wire not visible on gas piping to furnace or water heater.
- Task:** Further evaluation

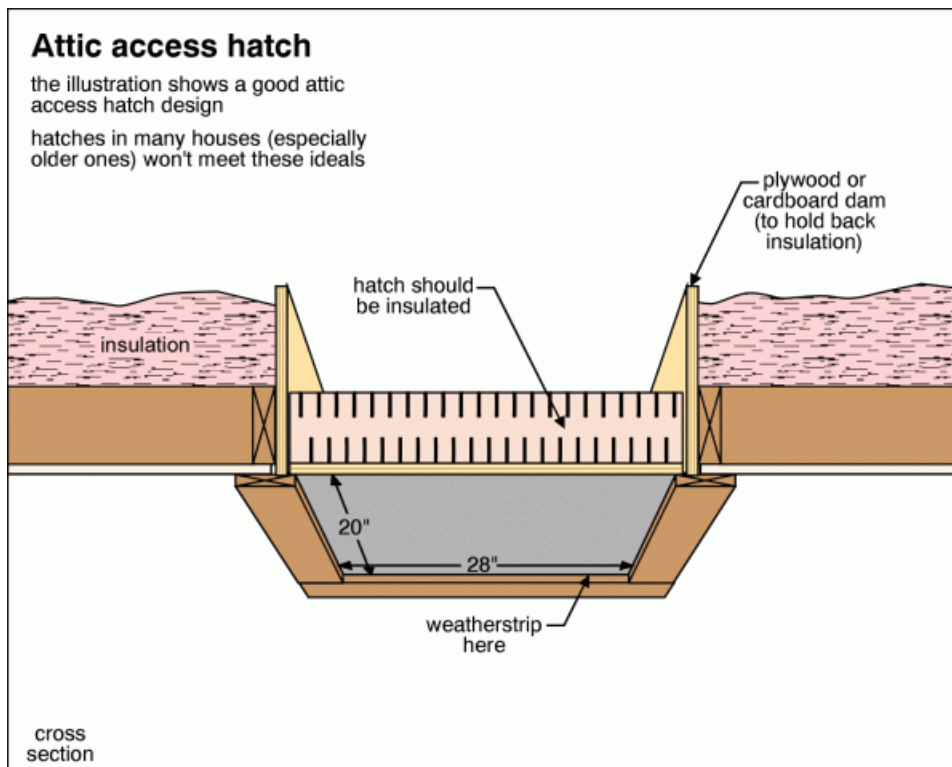
Condition: • Access Hatch: weatherstripping/fit less than ideal
Weather-stripping missing around attic access hatch.

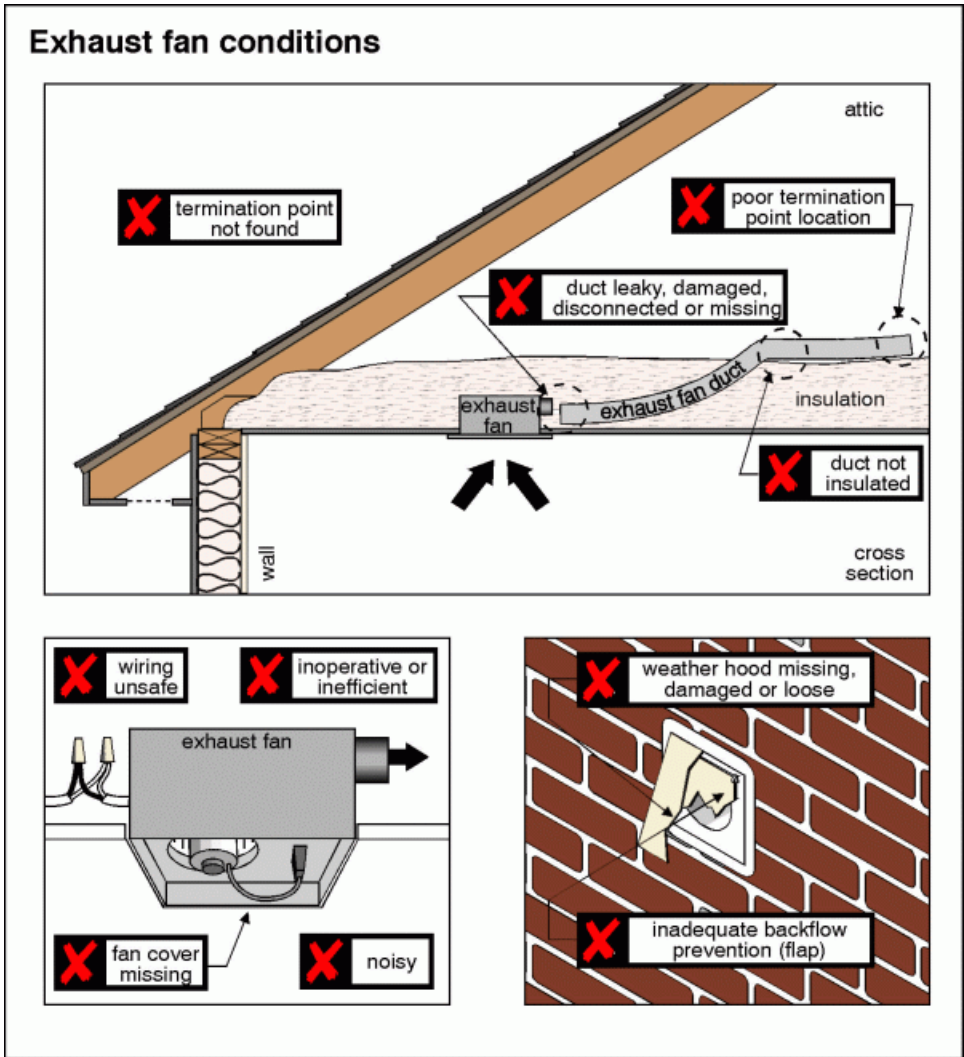
Condition: • [Discharge should be to exterior](#)
